## 1.0 Introduction & Exclusions

1.1 Capital PCC were engaged by Barnet Homes to undertake a desktop analysis and follow-up surveys, in order to establish the nature and extent of combustible cladding to low-rise properties (up to three storeys) within the borough which are believed to be timber framed. The action was prompted following the fire which occurred on the 8<sup>th</sup> of June 2023 and resulted in severe damage to a terrace of four, two-storey houses, resulting in a recommendation for all four houses to be demolished and the subsequent investigation report into the causes of fire spread undertaken by Capital PCC. Although there were no fatalities or serious injuries one householder had to be rescued as they were unable to self-evacuate. As a result, Barnet Homes wished to make an assessment of properties which were at risk of a similar occurrence, with a review of potential preventative measures.

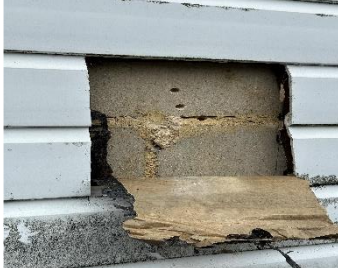
<p data-bbox="448 1545 784 1709">Party wall line, UPVC cladding fixed to blockwork via timber framing bridges compartment line.</p>

5.5.2 The compartment party walls are bridged by the combustible UPVC or timber cladding in some locations but not all, where adjoining properties have an existing fire-break arrangement they have been omitted from the in-scope properties. In the locations where the combustible UPVC cladding bridges the compartment line from one property to another there is the risk of secondary fire spread. However, the effect of this on the risk to life and property is diminished by the non-combustible masonry backing structure.

8.2.5 Remediation of Type 2 could be limited to the replacement of the cladding, soffits and fascia's only, due to the limited areas this would not fall under the rule for the requirement of a thermal upgrade, however other works to ensure the continuation of the vertical line of compartmentation would be required e.g. cavity barrier at the party wall line and fire stopping within the eaves.

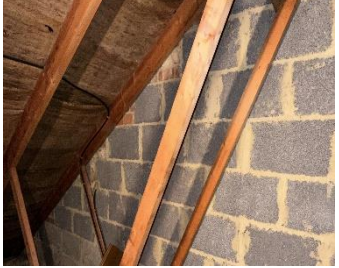
<p data-bbox="805 1545 1141 1671">Timber truss roof with masonry which appears to meet the underside of the roof covering</p>

5.5.3 It was noted that the dividing party walls in the roof-spaces appeared to meet the underside of the roof covering without any significant gaps noted. However, at eaves level behind the fascia boards, gaps in the fire stopping continuity were noted.

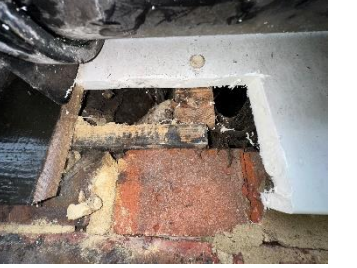
<p data-bbox="1162 1545 1516 1671">Junction of party wall behind the fascia, there is a continuity gap which should be fire stopped</p>

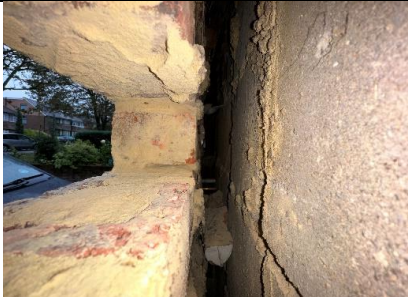
5.6.1 None of the properties so far investigated had any insulation within the walls. The masonry cavity wall was opened and this revealed no cavity wall insulation present and limited amounts within roof spaces.

Masonry wall with empty cavity 70mm

This gives an opportunity to upgrade the thermal performance of the houses by installing cavity wall insulation of up to 70mm depth in the walls; loft spaces could also be considered for upgrades. Separately or combined, the insulation upgrades will have an impact on both the thermal performance and associated EPC scores. However, with this archetype Building Regulations would not require an insulation upgrade to the walls as part of any cladding remediation due to the limited area of wall covering affected.

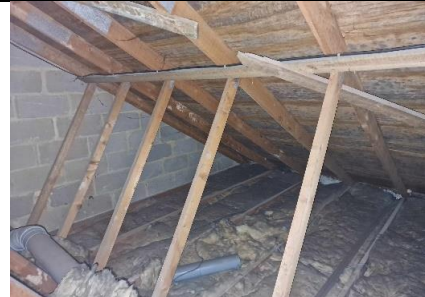
Loft insulation 100mm

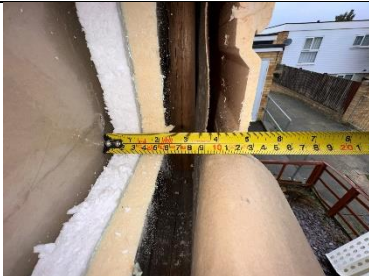
<p data-bbox="423 831 789 894">Wall build-up, upper floor front</p>

5.7.1 Investigations into selected limited locations, revealed that the properties are of timber framed construction with external continuous UPVC cladding fixed to the upper floors and a mixture of gravel dashed fibre reinforced resin / plastic sheet cladding to the lower floor at the front and a cement particle cladding sheet board to lower floor at the rear. There is also a mix of insulation types within the walls comprising of EPS sheets, thermoset foam sheets and loose fill mineral wool, the insulation types only partially fill the void within the timber framed walls.

5.7.2 At the vertical compartment party wall line, the outer wall consists of a continuation of the timber framed, external wall arrangement so there is effectively no fire break arrangement within the external wall between separate units.

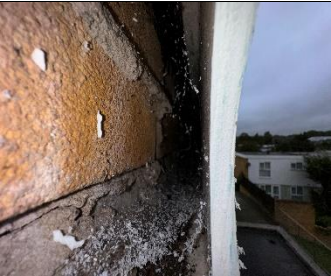
<p data-bbox="821 831 1149 894">UPVC fascia with continuous cavity behind</p>

5.7.3 As the Type 4 archetype have flat roofs there is no traditional eaves detail but instead a continuous UPVC fascia board which covers the junction between the head of the external walls and the roof. Directly behind the UPVC fascia board there is a continuous cavity which offers an unrestricted route for the spread of fire from one unit to another.

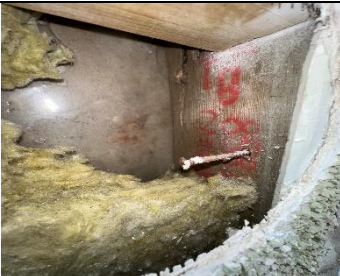
<p data-bbox="1182 831 1520 894">Wall build-up, lower floor front</p>

5.8.2 The lower section walls contain 50mm loose fill mineral wool fibre insulation.

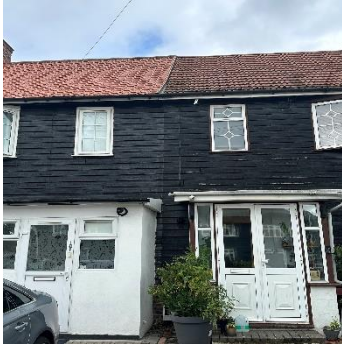
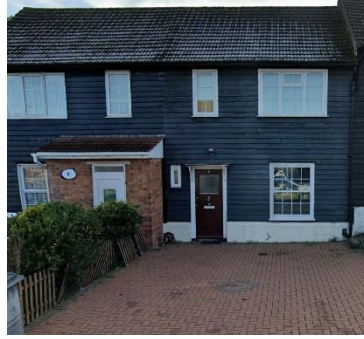
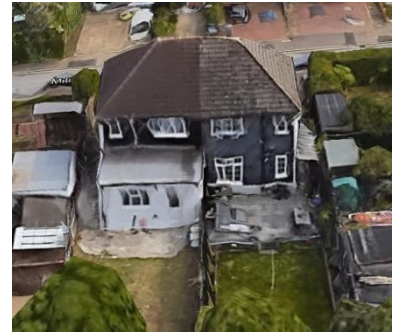
8.4.2 However from a technical & buildability perspective, this potential option is unlikely to be feasible as a universal solution as many of the houses have porches to the front and / or rear extensions which are built right up to the party wall line and such arrangements will prevent any extension of the party wall being brought forward as a fire break.
