**Response to Comments on my
Report on the Fire at
9 – 15 Moss Hall Grove, North Finchley, N12 8PE
on the 8th June 2023
by**

Ref: AC-5

6th September 2024

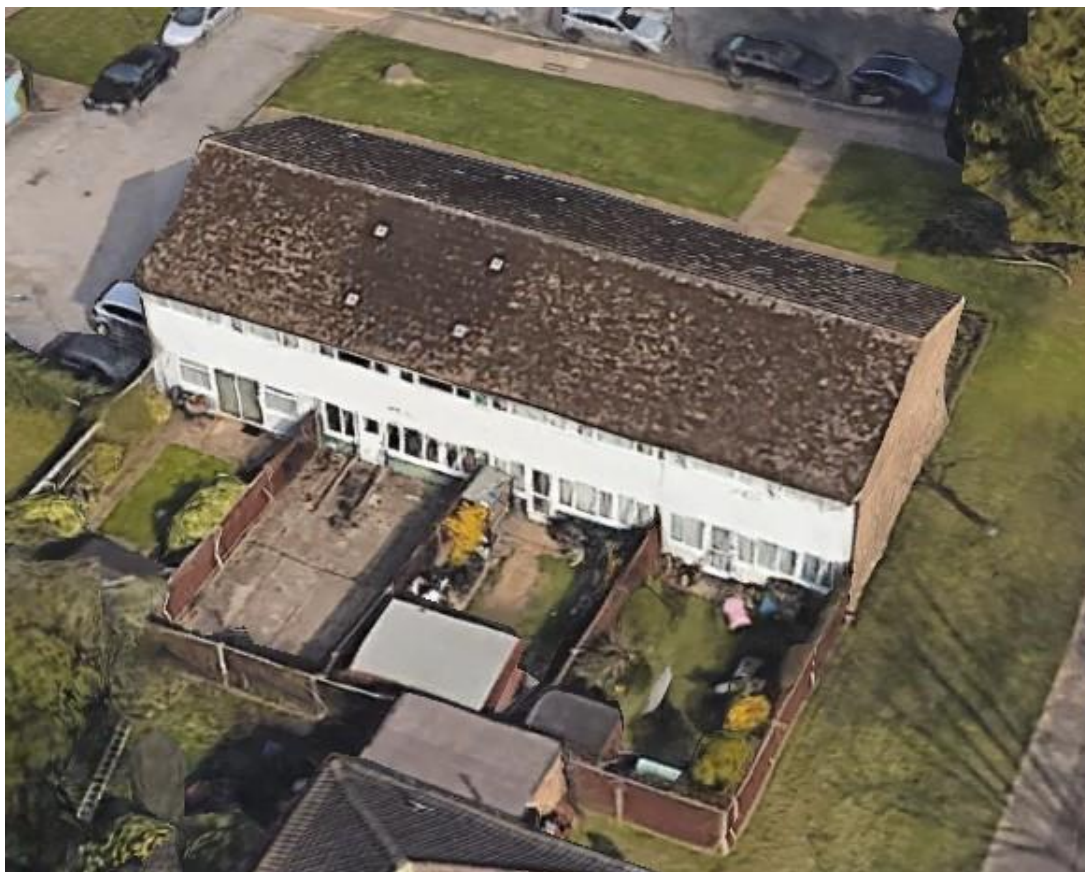
Para 2.18: I agree that my photograph 4 cannot be taken as showing the items that were present in the yard on the day of the fire. Photograph 1 of this present report provides a clearer version of this view. Another aerial view, on an unknown but different date is shown in photograph 2 of this report. There is what appears to be a gazebo in the garden. I accept that I have no evidence of a gazebo being present during the fire but the various aerial views, together with the quantity of debris that was present in the yard after the fire, do lend support to my view that there might well have been a high fire-load there. Houses in the UK are not required to resist ignition from a large external fire burning in close proximity.

1. A clearer version of photograph 4 in my report dated 16/7/24. The cedar tree at the front of the terrace has already been felled so this view must be after June 2017. The yard of no 11 is relatively uncluttered. I do not know why the roof of no 13 is different.

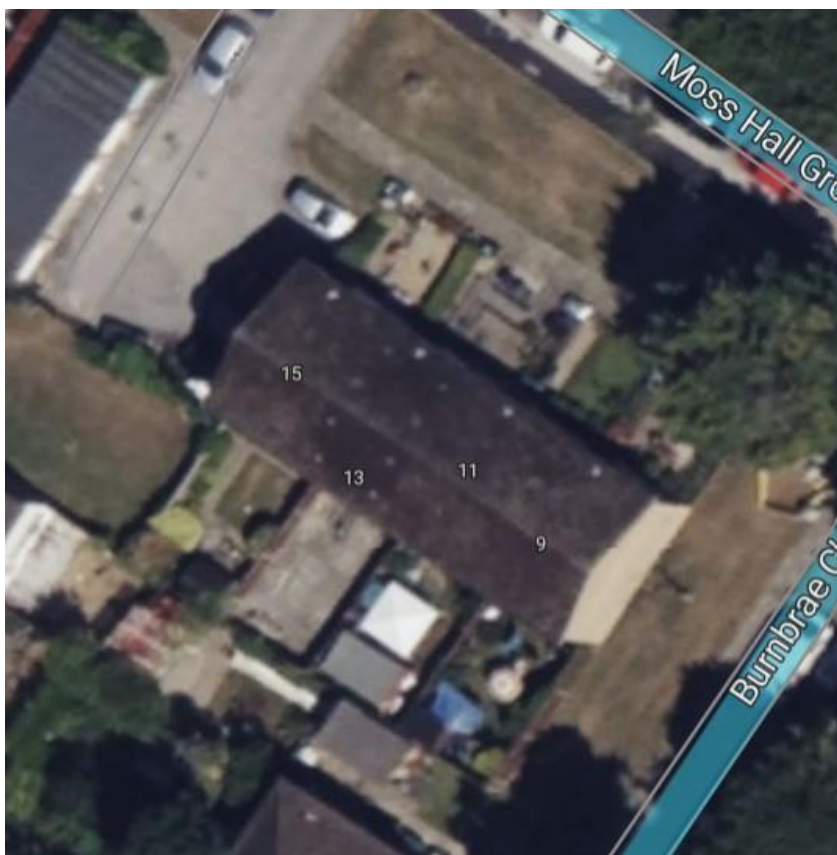
2. An image from Bing Maps, taken on an unknown date after June 2017. The yard of no 11 contained what appears to be a gazebo at this time. The yellow shrub visible in the previous photograph seems to have been removed.

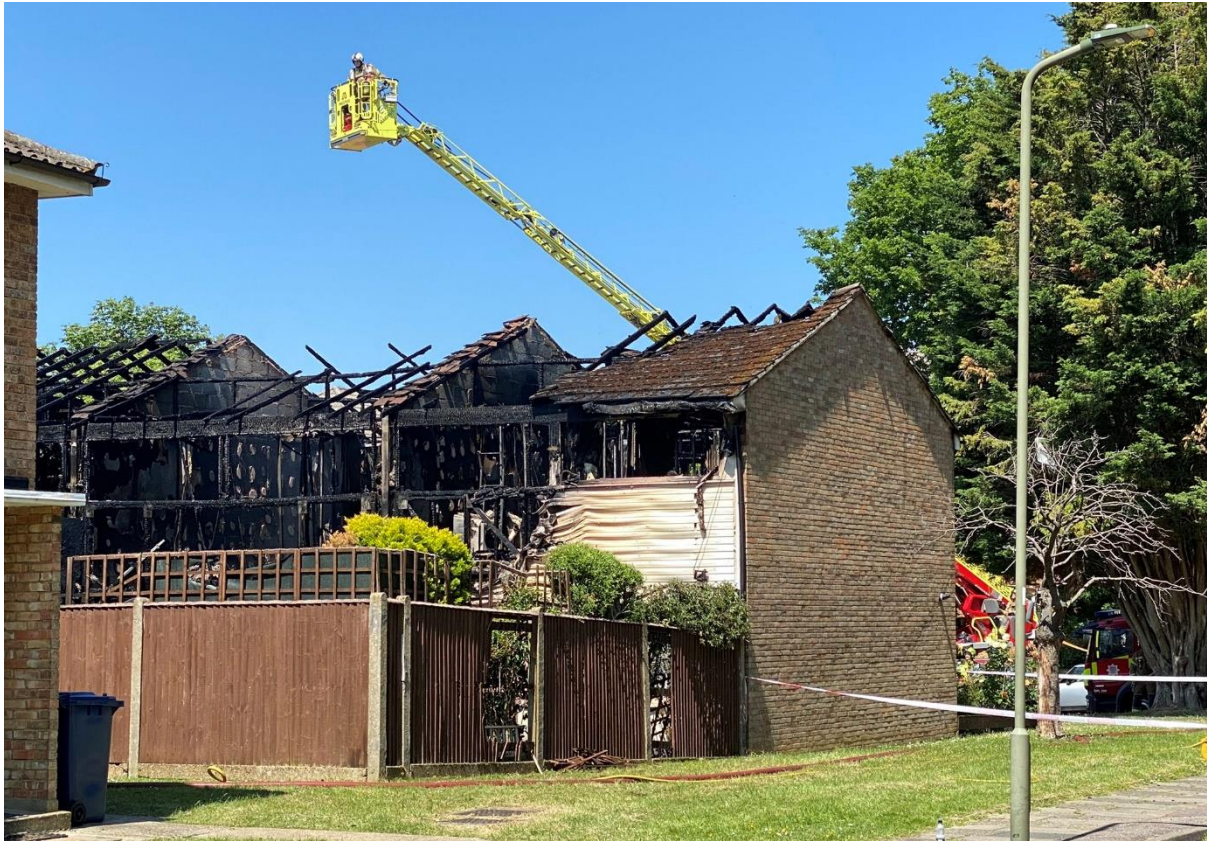
Para 4.4: Subsequent to writing my report, I obtained a photograph that provided a clearer view of the destruction of the roof above the party walls – see photographs 3 & 4 of this present report. No remains of fire-stopping are visible. This new photograph does not change my view on this aspect which, in any case, does not seem to be in dispute. Had the initial fire affected only house 11, once its roof void became involved the fire would almost certainly have quickly spread into the roofs of houses 9 and 13 via gaps above the heads of the party walls.

3. This photograph, from social media, was taken during the final stages of fire-fighting. It gives a better view of the head of the party walls than photograph 6 in my report of 16/7/24. Charred pieces of tiling battens remain in place where they pass over the party walls. There should have been fire-stopping between the battens where they pass over the party wall but none is visible, suggesting that it was never present.

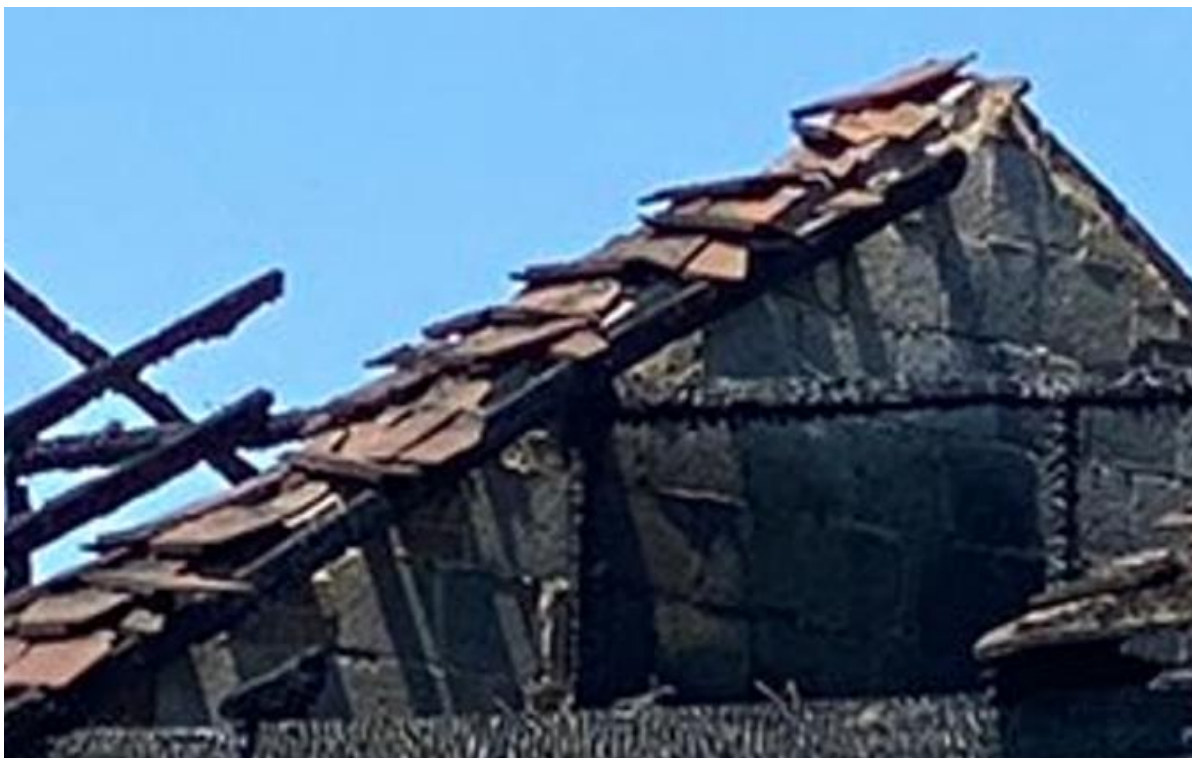
4. A closer view of the head of the party wall between houses 11 and 9.
